A SELECT REST

A 1965 Ford 4000 with Select-O-Speed transmission provides a test for these enthusiasts who are restoring the machine for the Hamilton Pastoral Museum in Australia.

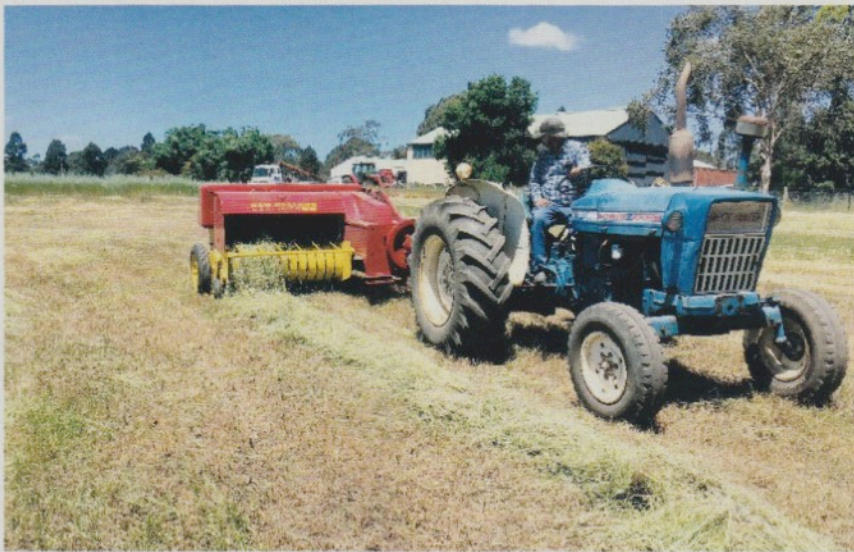
The Ford 4000 operating a New Holland Hayliner 68 baler at a hay demonstration before any work to find the two missing reverse speeds. The tractor is as donated.

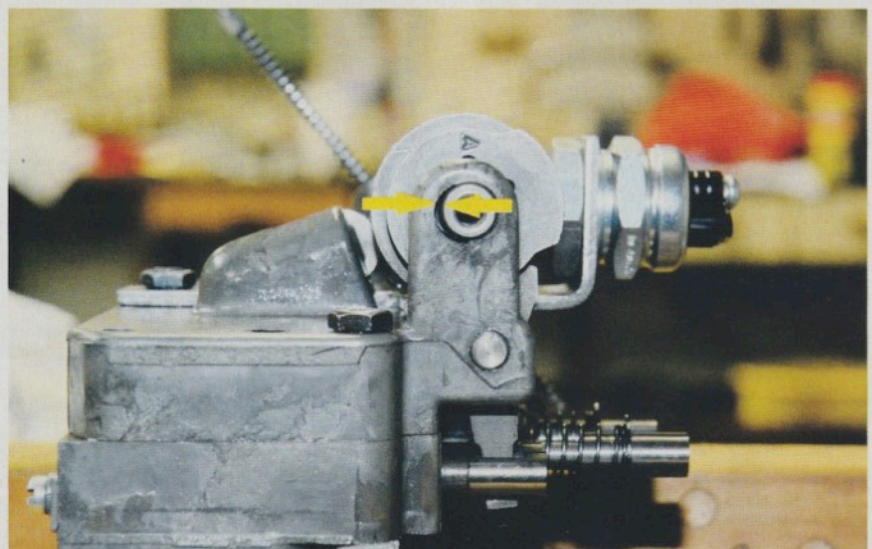
Wear found at left-hand end of Select-O-Speed control valve camshaft. This was left 'as is', mainly because there is no dimension provided for the centre of the bore.

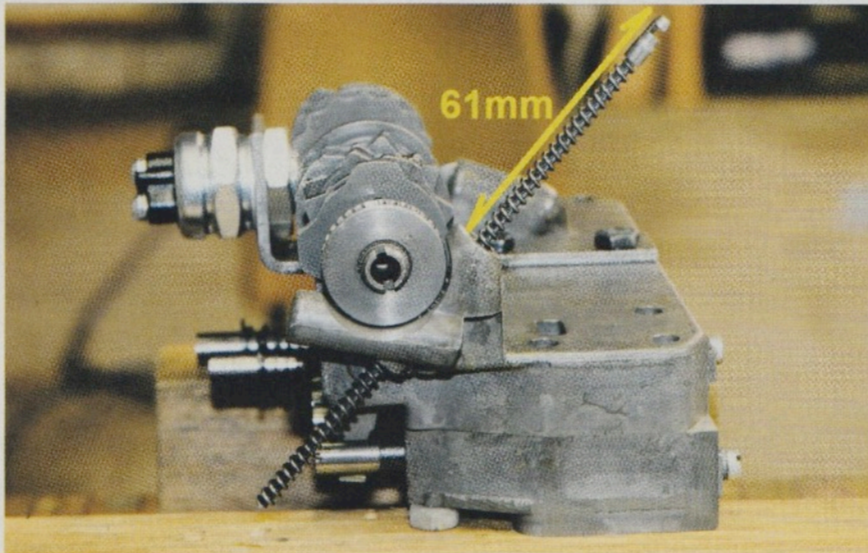
The set-up dimension for the lower segment of Select-O-Speed control cable.

The transmission control assembly was adjusted so that the lower cable joint protruded $\frac{1}{4}$ in from the lower end of the conduit, with the control lever set at the 10th speed position. The large clamp nut (29mm across flats) was not fully tightened at this stage, because the indicator quadrant could require fine adjustment during installation on the tractor. New housing cage nuts and stainless-steel machine screws were obtained for fitment to the tractor. The repaired unit was returned to the museum in Hamilton, right at the time of our

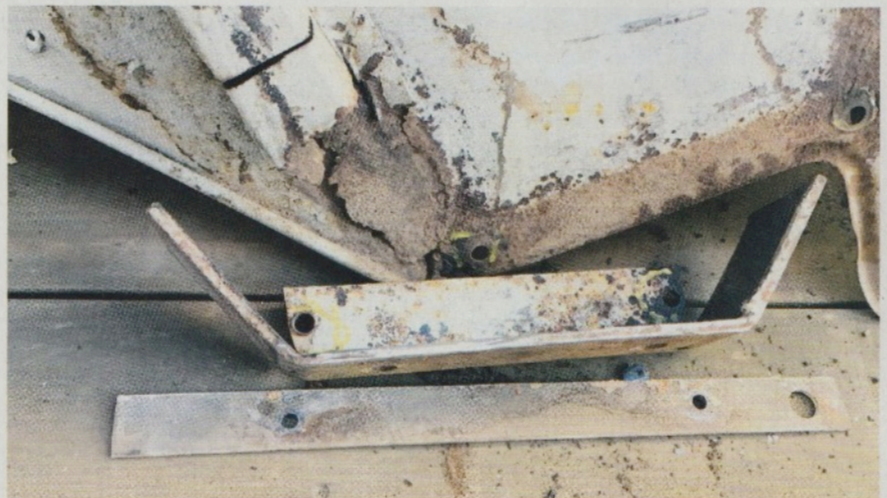
Severe rust at base of mudguard, both were affected in the same way.

The mudguards were badly corroded where they bolt onto the rear axle. A local sheet metal worker has kindly assisted with welding new metal into the guards. The hydraulic three-point linkage has been removed for sandblasting before repainting. The seat required replacing, and its removal caused some drama. At the rear of the mounting, the nut had rusted firmly onto the stud, and that stud unscrewed itself from the hydraulic top cover. A peg was discovered at the inner end of the stud. This caused some concern about the peg's fine adjustment. It took a bit of persuading to convince that the stud should have the seized nut removed and then be threaded into the housing right to its shank with a drop of Loctite 262 to keep it securely in place.

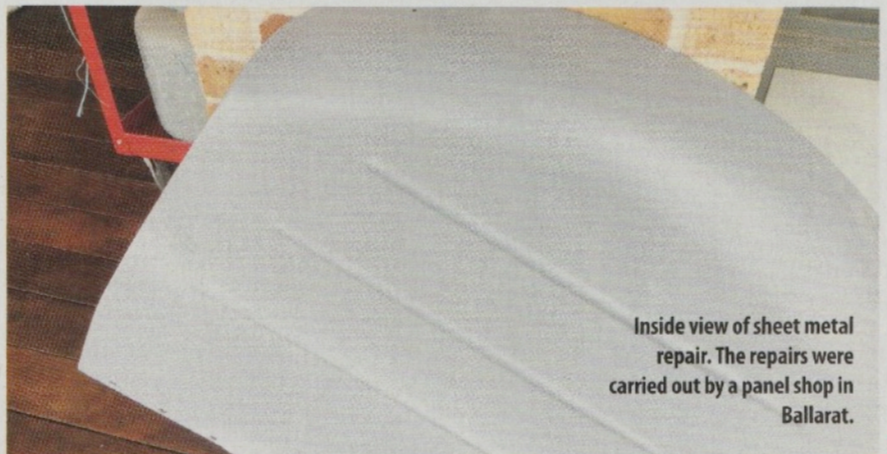
Inside view of sheet metal repair. The repairs were carried out by a panel shop in Ballarat.

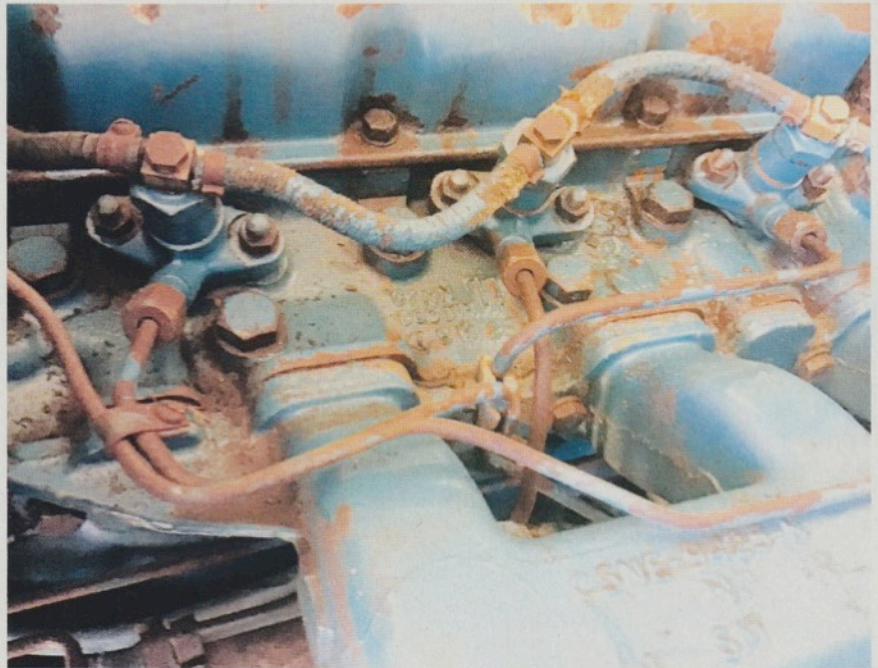
The injectors prior to removal and reconditioning. Damage from a leaking battery is evident.

The engine has, since the museum's custodianship, been difficult to start from cold. This could be a worry, due to free use of Aerostart and maybe, bent connecting rods. The thermostat has been replaced and the injectors have been thoroughly serviced. We are hopeful of a good result.

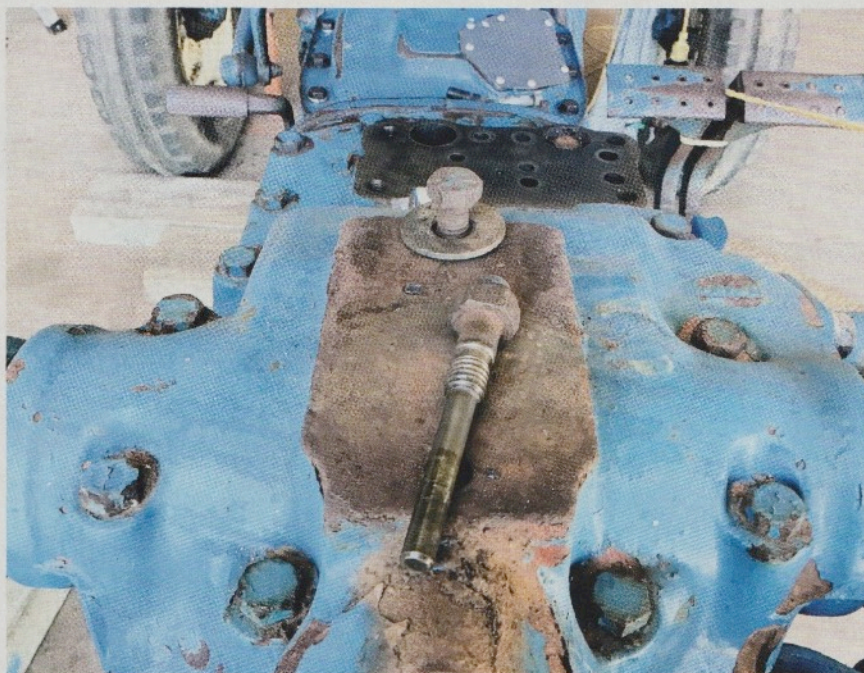
The peg stud that unscrewed out of the hydraulic top cover. It was beneficial that the three-point linkage had been removed and the peg stud could be threaded back in place after the nut had been removed.

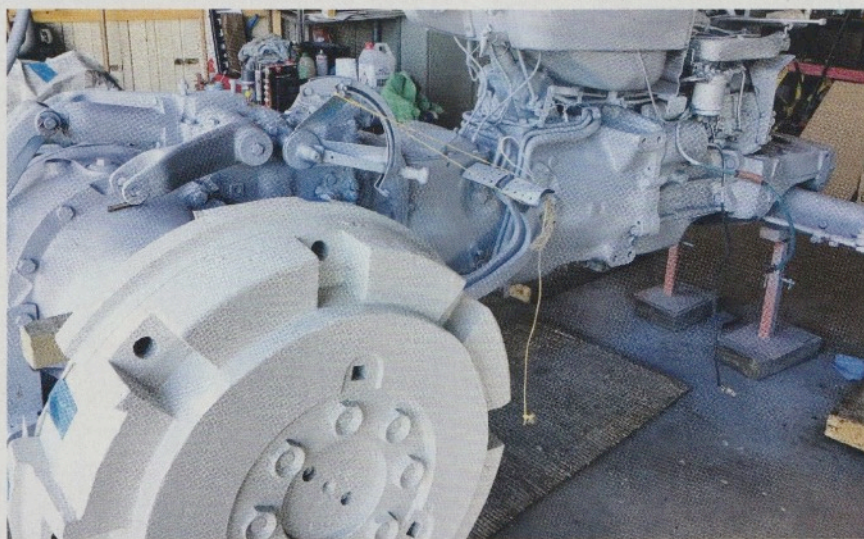
The Ford 4000 in undercoat awaiting blue topcoat.
